# Navajo Abandoned Uranium Mine Site Screen Report

**Kermac No. 22 AUM Site**

**Navajo AUM Eastern Region**

**May 2009**

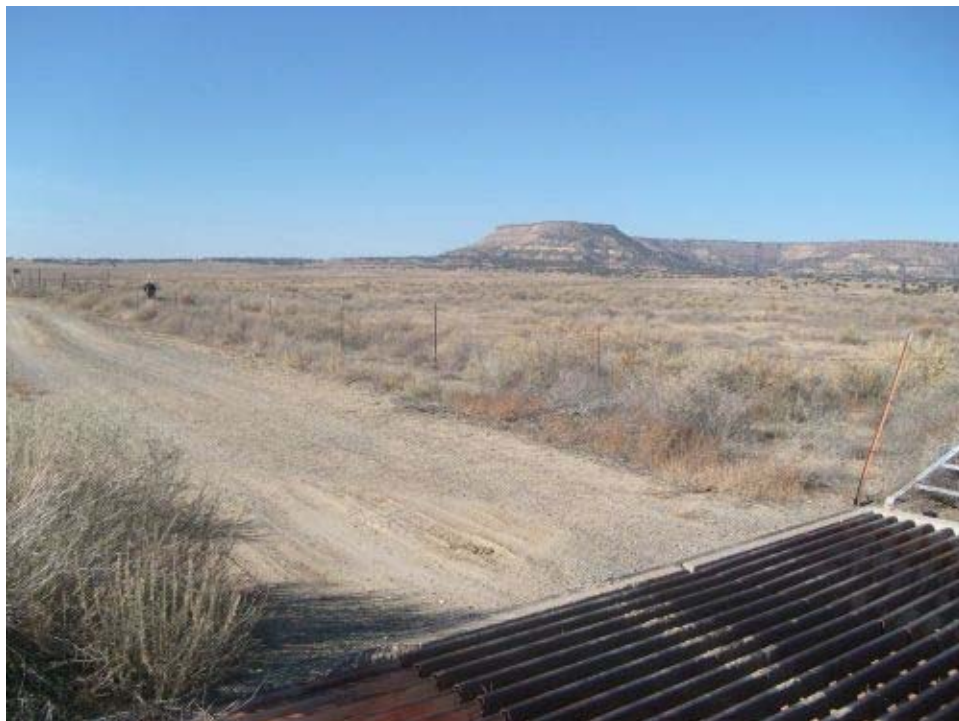
Photo 1. Kermac 22 mine site, towards west/southwest from road at northeast corner of site

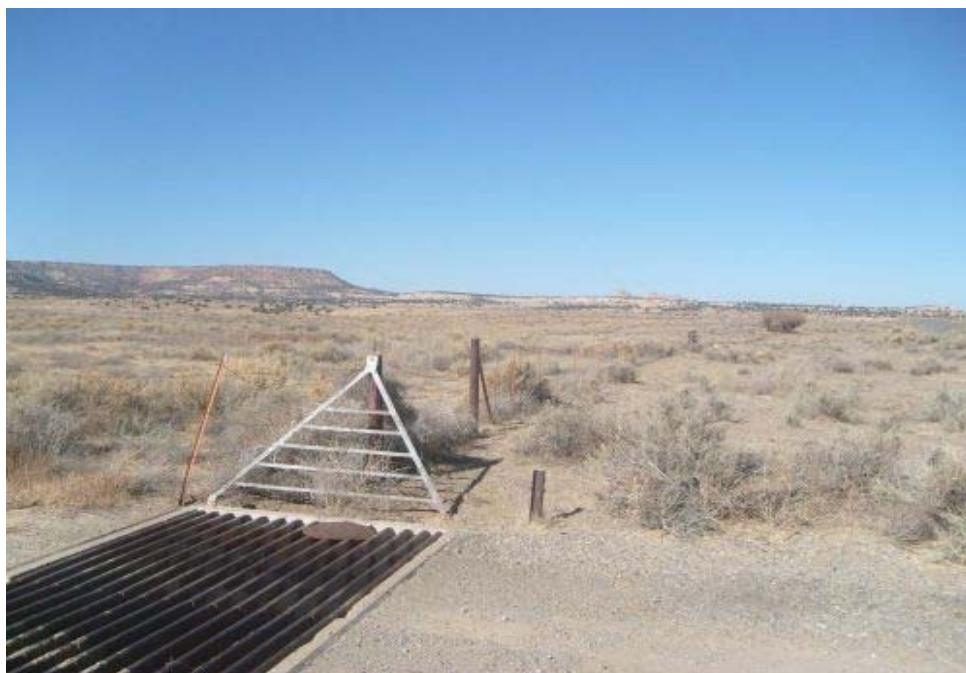
Photo 2. Kermac 22 mine site, towards west/southwest from road at northeast corner of site

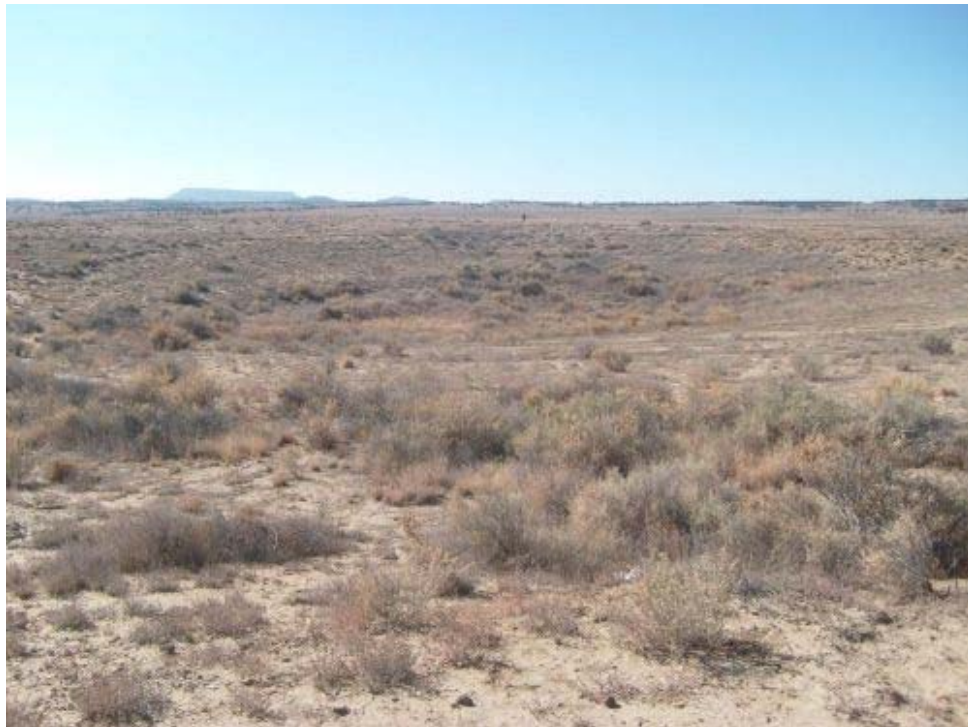
A total of 4,842 gamma radiation measurements were collected from the mine site, ranging from 11,268 cpm to 227,145 cpm. An area of depression within the site was measured at approximately 20,000 cpm. The measurements are represented in Figures 1 and 2.

Photo 4. Large depression south of road

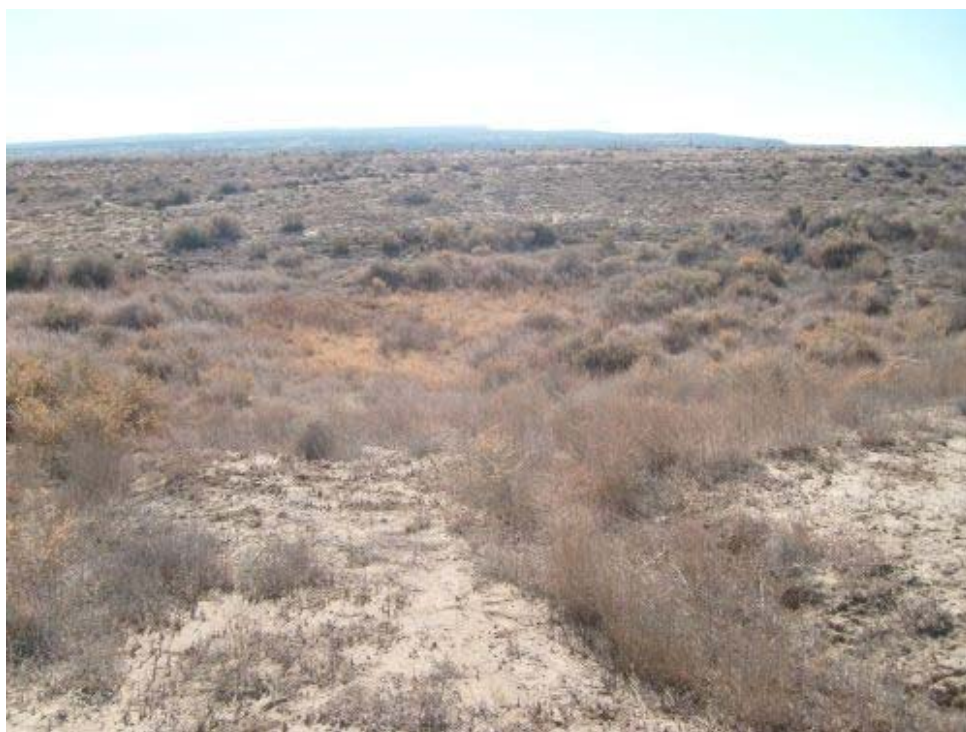
Photo 5. Large depression south of road
